The U.S. Fish and Wildlife Service (Service) proposes to stabilize five abandoned houses and hunting camps at St. Catherine Creek National Wildlife Refuge in Adams County. The houses currently serve as roosting areas for small colonies of Rafinesque's big-eared bats (*Plecotus rafinesquii*), a poorly known species formerly listed as a Category Two species by the Service. On June 16 and 18, 1999, I examined the structures to determine their eligibility for inclusion on the National Register of Historic Places. Four of the structures were determined ineligible due to their recent construction date and style. However, one house - "the White House" - was deemed potentially eligible under Criteria C and D. To facilitate your review and comment, I have enclosed copies of Hall's 1998 **Artificial Habitat Stabilization Project to Benefit the Rafinesque's Big-Eared Bat (*Plecotus rafinesquii*) on St. Catherine Creek National Wildlife Refuge, Sibley, MS** and a completed Region 4 Architectural History and Historic Narrative form for the "White House." The results of the historic structure assessments are summarized below.

Historic Structure Assessments

ARCHITECTURAL HISTORY AND HISTORICAL

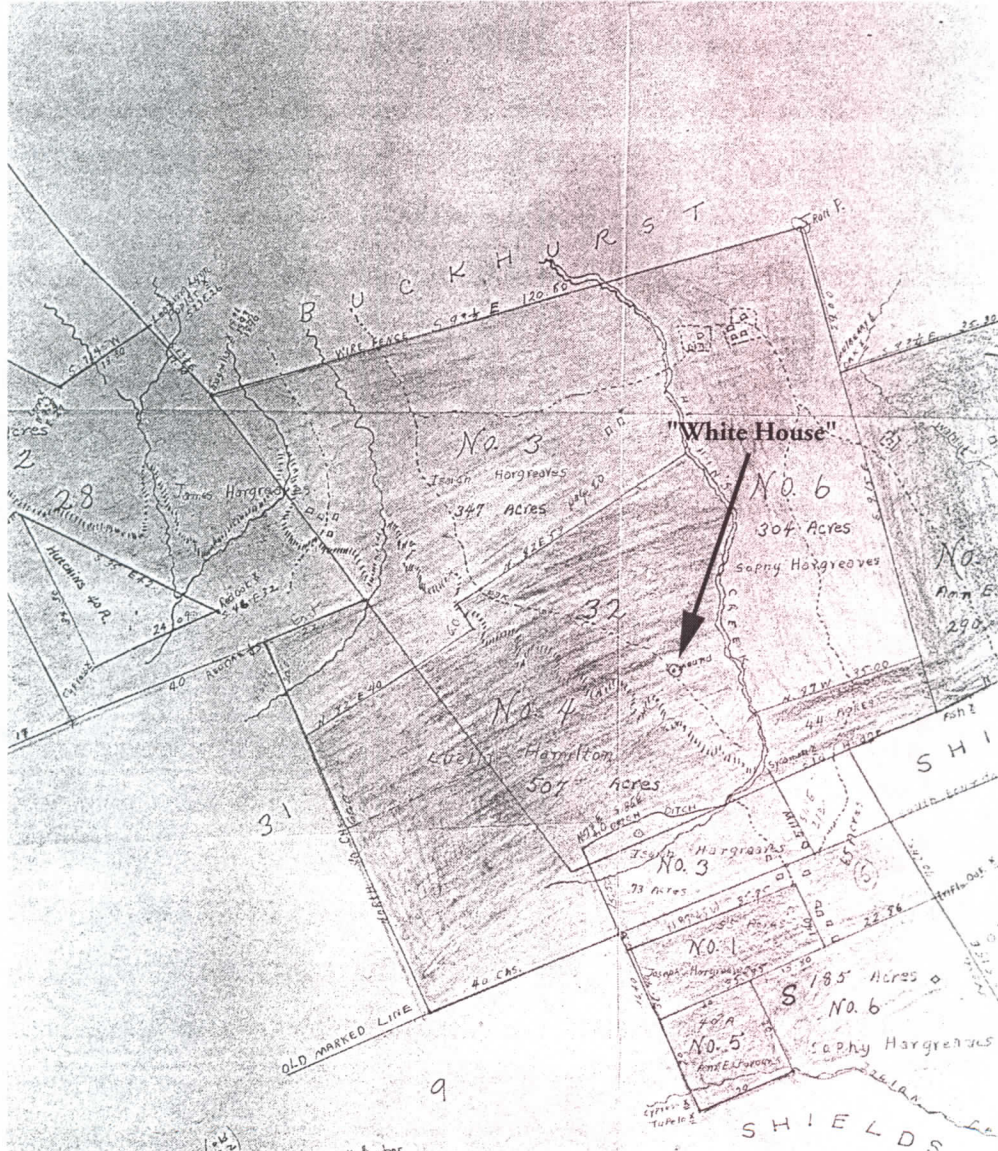
Plat Map

Section from an undated plat map of York and Bourbon Plantations which shows the location of the "White House" (St. Catherine Creek National Wildlife Refuge: n.d.).

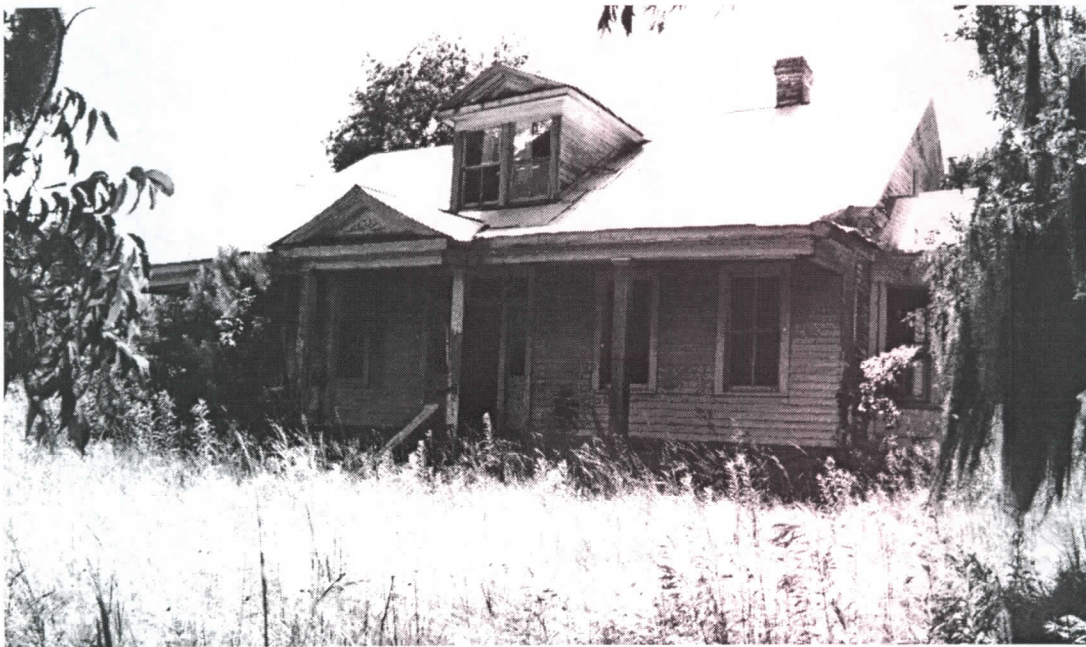
Photograph 1. "White House" - Front (East Elevation).

Style and/or Period Greek Revival (Photographs 1 - 4, 15 & 16).

Roof Type Side-Gabled and covered by corrugated sheet metal. Common Rafter System overlain by lattices. Slight eave overhang with wide divided cornice band. The extended rear shed ell is covered by asphalt shingles (Photographs 1 - 3, & 15).

Secondary Roof Structure(s) Pedimented gable center dormer with clapboard sidewalls. The dormer has two 2/2 sash windows (Photograph 1).

Windows Symmetrical arrangement of 2/2 double hung sash windows in the older portion of house (Photograph 1). The parlor has a projecting bay composed of three 2/2 double hung sash windows. The bay has a triangular pediment with central sun burst decorative pattern and a gable roof covered by corrugated metal sheets (Photograph 10). One 6/6 double sash window is located below the eaves of each gable. These windows are separated from the decorative sun burst pattern by a horizontal trim piece. A pair of 6/6 double hung sash windows are located in the shed ell on the north gable end (Photograph 11). Shutter hardware indicates that shutters were once present. The fenestration of the west elevation was altered with the construction of the shed ell - they were either blocked (rear bedroom) or modified into an interior connecting door (old kitchen).

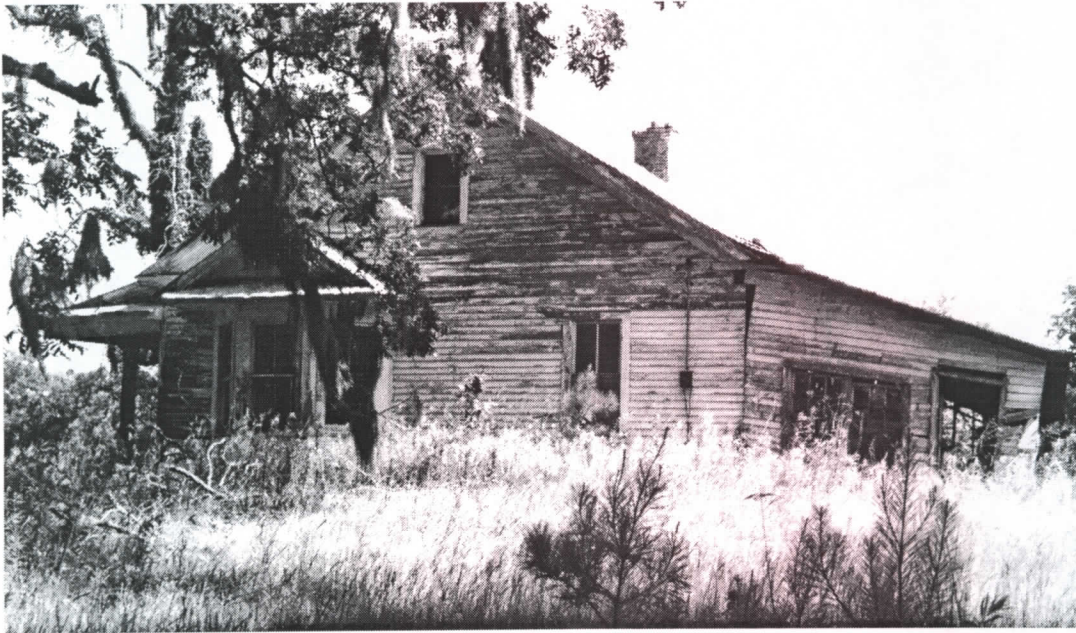
Photograph 2. "White House" - North Elevation.

Exterior Doors Unknown, but both front and back single doors are surrounded by a broken transom light and $\frac{2}{3}$ side lights set in a simple entablature (Photograph 9). A raised panel is set in bottom third of each side light. A secondary exit is present in rear shed ell and is located on north gable facade (Photograph 2).

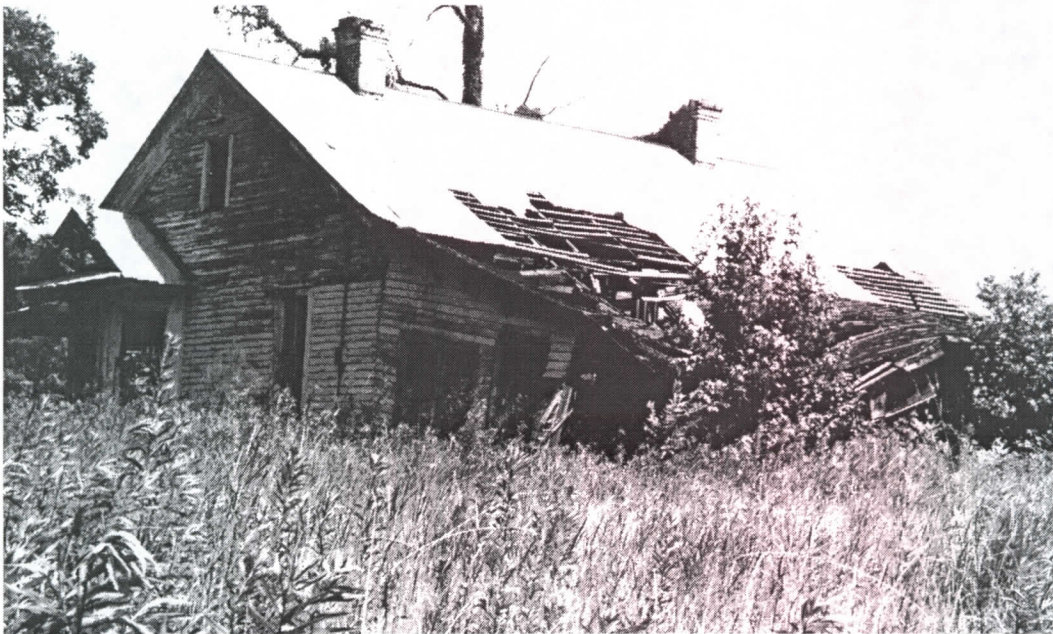
Photograph 3. Northwest corner. Note poor condition of extended shed ell, the central portion of which has collapsed. Several sheets of corrugated metal have slid off the older portion of the house.

Structure	Proposed Work
"White House"	<ul style="list-style-type: none"> • Remove collapsed back porch/ell. • Repair rear elevation upon removal of the back porch/ell. This work will be limited to re-nailing detached clapboards if possible and/or nailing sheets of plywood to those areas where clapboards are missing or beyond repair. • Repair damage to the roof was damaged by tornado by replacing missing corrugated metal sheets. • Stabilize roof dormer by installing wood bracing in the house's interior. • Install one steel door. • Install steel excluder devices on ground-floor windows and remaining door. The attic windows will remain unobstructed to provide access for the bats and other non-targeted species. • Remove fallen ceilings, rotten floors, and other accumulated flammable debris.

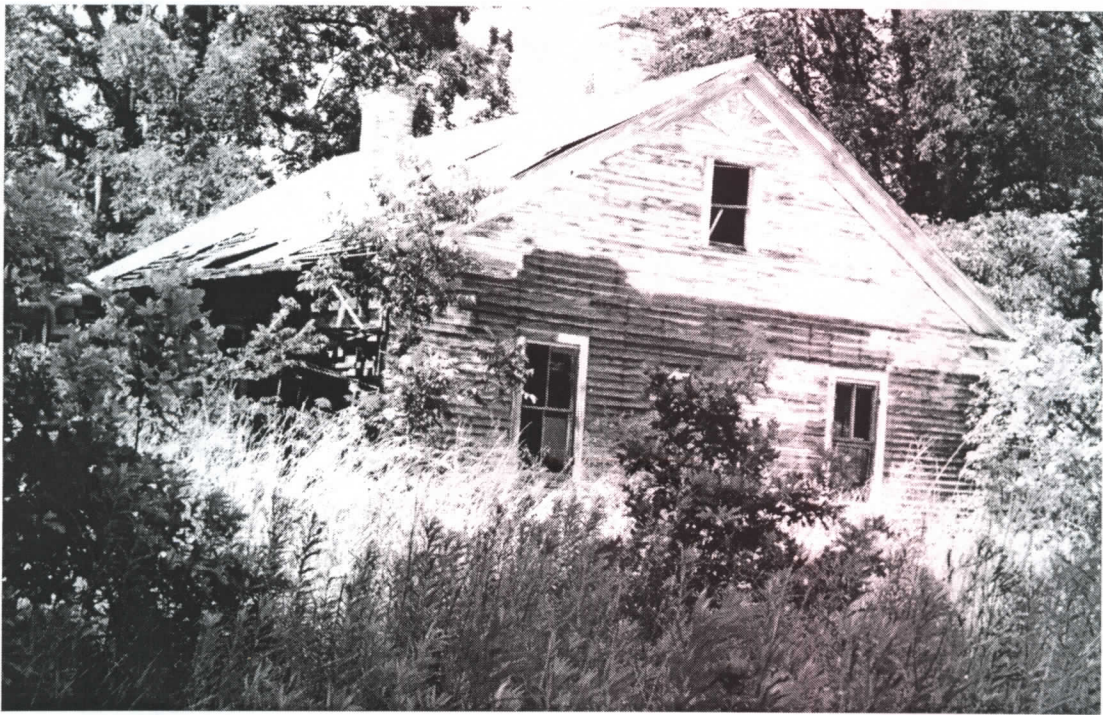
Photograph 4. Southwest corner.

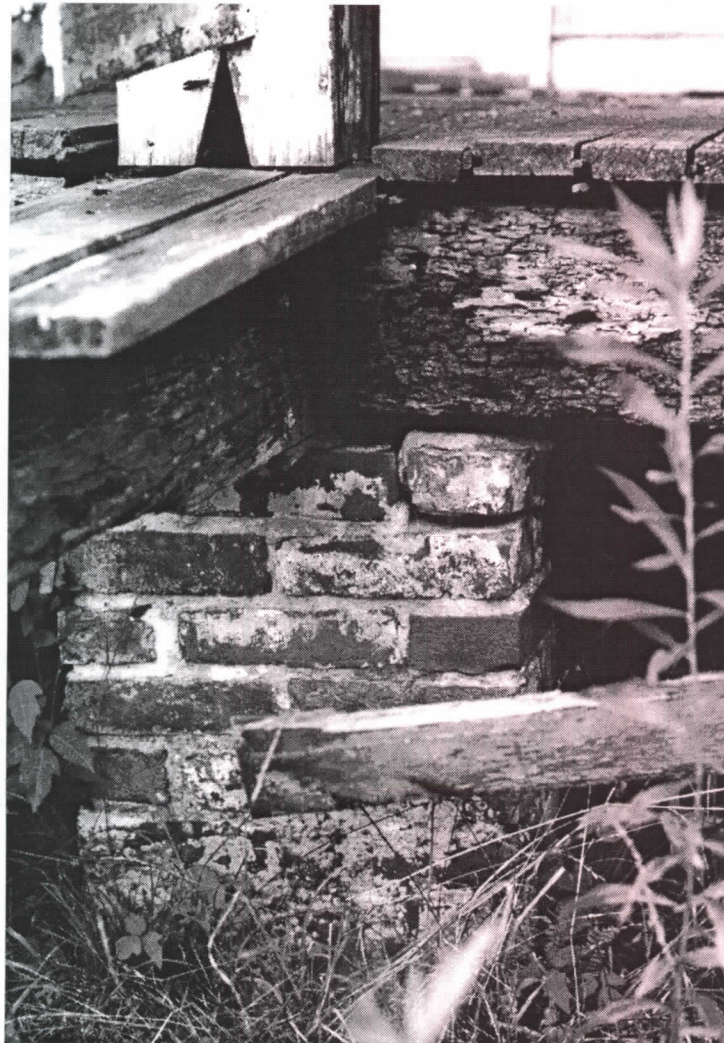
Photograph 5. Brick pier. Note tongue and groove board decking of the porch and the insect- and water-damaged sills.

Foundation Brick Piers (Photograph 5). Diamond-shaped lattice work set between piers (Photograph 6).

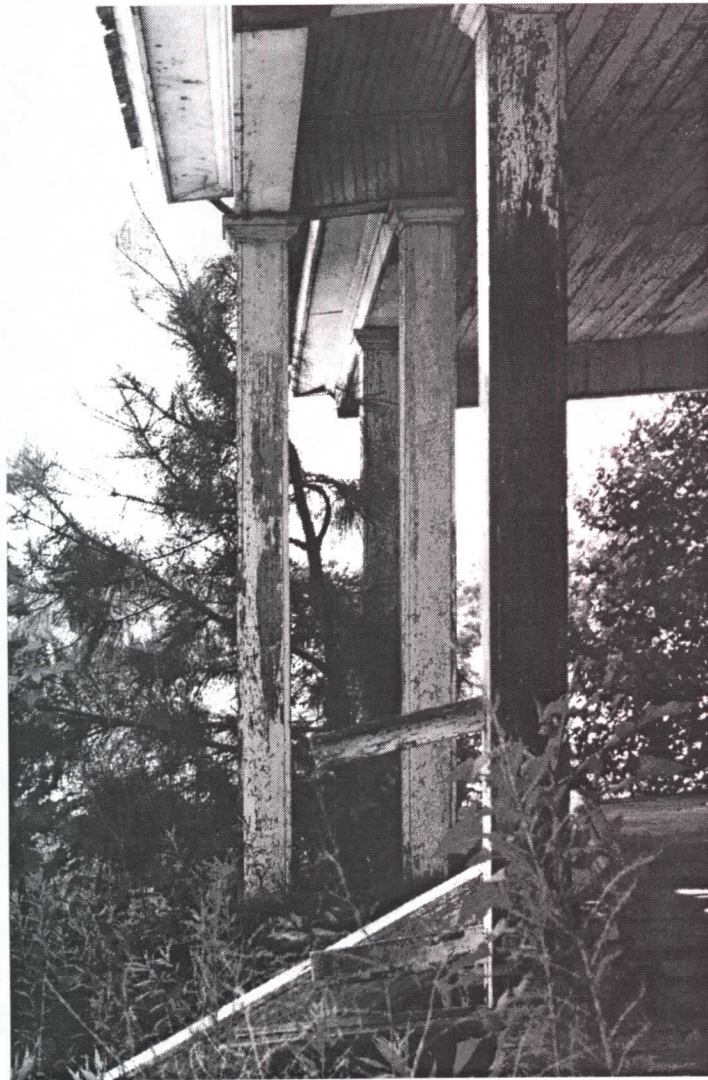
Photograph 7. Square vernacular columns with simple Doric capitals support the porch.

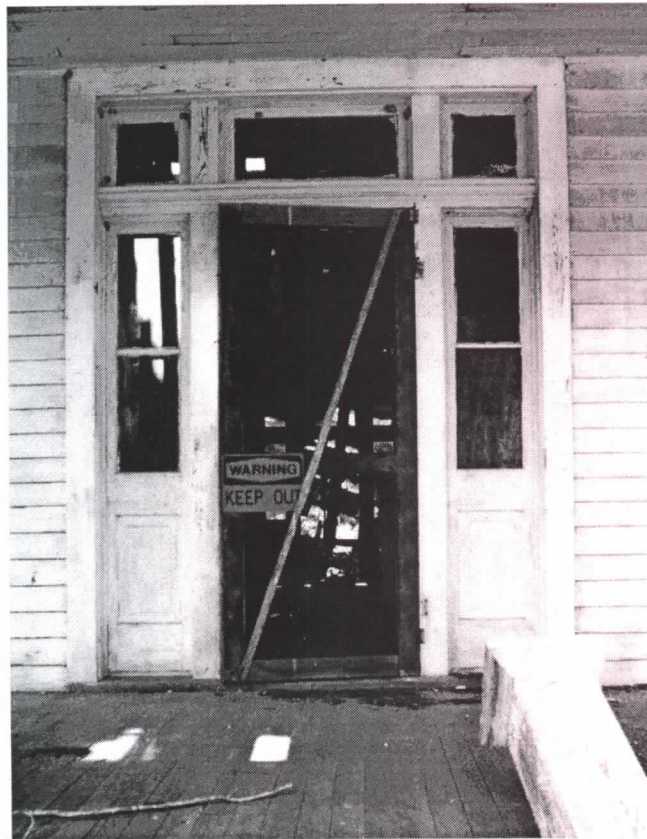
Photograph 9. Main entry flanked by a broken transom light and $\frac{2}{3}$ sidelights.

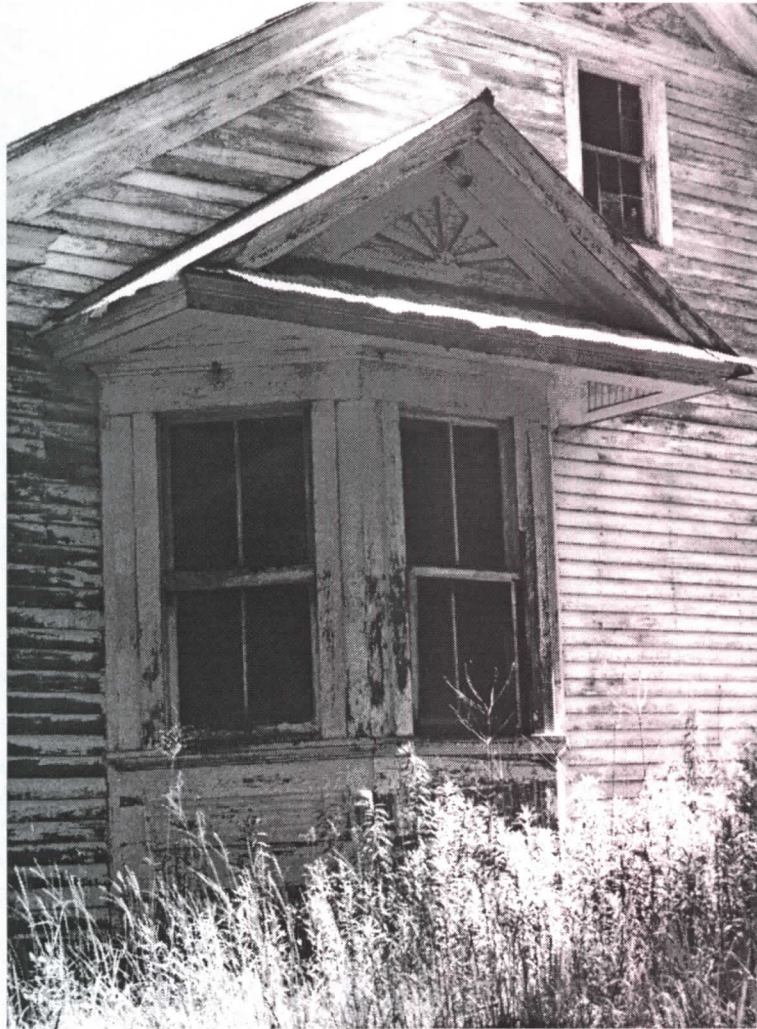
Photograph 10. Parlor bay with triangular pedimented gable roof and trio of 2/2 double hung sash windows. A 6/6 double hung sash window located just below the eaves can be seen in the upper right corner.

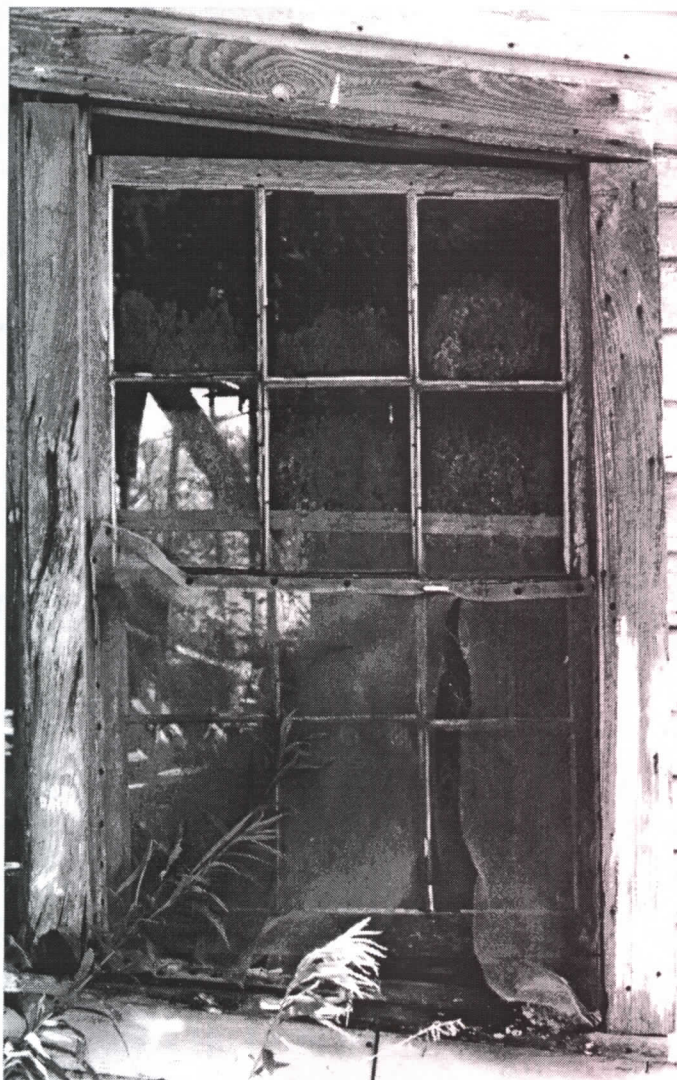
Photograph 11. 6/6 double hung sash window in extended shed ell, north elevation.

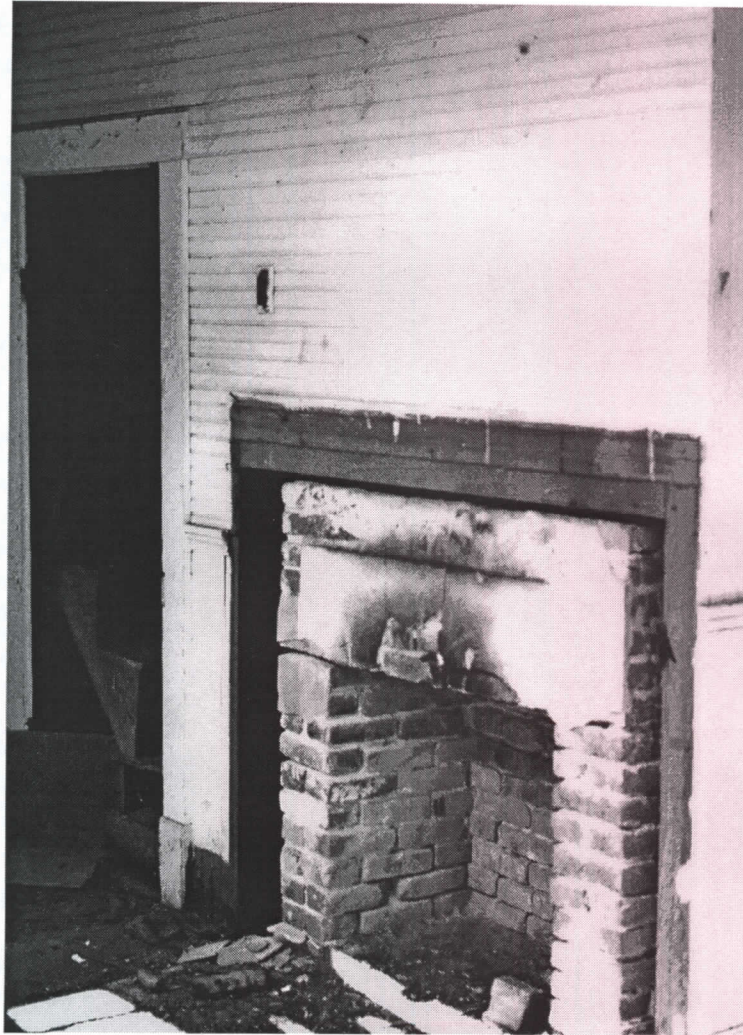
Photograph 12. Fireplace in the "old kitchen." Note the doorway and stairs which lead to the attic.

main rooms. Square firebox; mantles have been removed (Photograph 12).

Walls - Narrow tongue and groove boards separated by a wainscot in the hall, kitchen, and parlor. Boards below the wainscot run vertically; above it they run horizontally. No wainscot is present in the other two rooms. Here the tongue and groove boards run vertically from floor to ceiling. Each room has wide flat baseboards (Photograph 12).

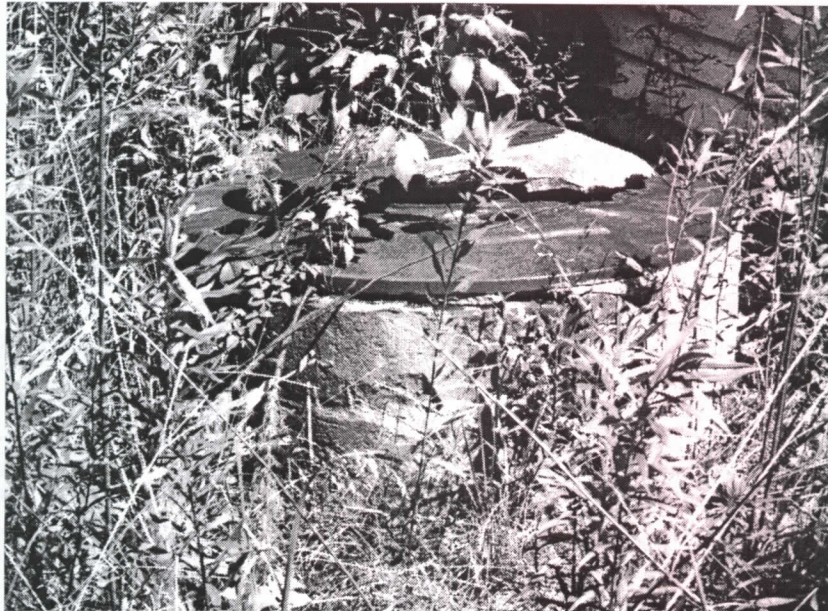
Photograph 13. Circular brick well.

Miscellaneous Circular brick well located north of house and near rear door of shed ell addition (Photograph 13). Concrete stucco has been applied to the well's exterior. Metal lid on well. The manufacturer's mark is stamped on the lid -

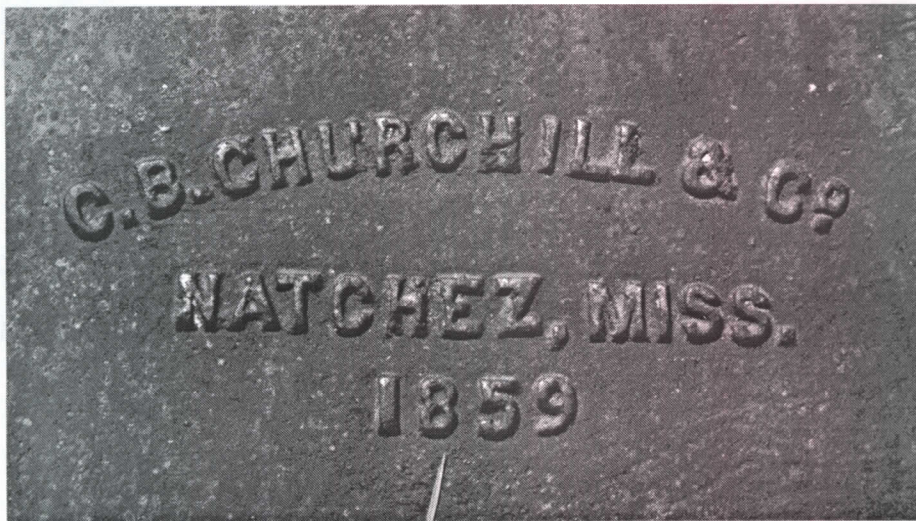
Photograph 14. Manufacturer's mark on the well's cover.

C.B. CHURCHILL & C^O.
NATCHEZ, MISS.
1859

The house appears to have been built in the mid-late 19th century, a conclusion supported by the 1859 date on the well cover. The shed ell was added in the early-mid 20th century based upon an examination of the materials used for construction. The undated tract plat (Map 2) shows that the house was built on top of a "mound" and raises the possibility that an earlier Native American occupation lays beneath the historic archaeological deposits. Additional documentary research (deeds, maps) and oral history interviews (Norman Haigh, former owner of Sibley Farms) need to be conducted and will provide more definitive information regarding the site's owners, land use patterns, and dates of construction/modification.

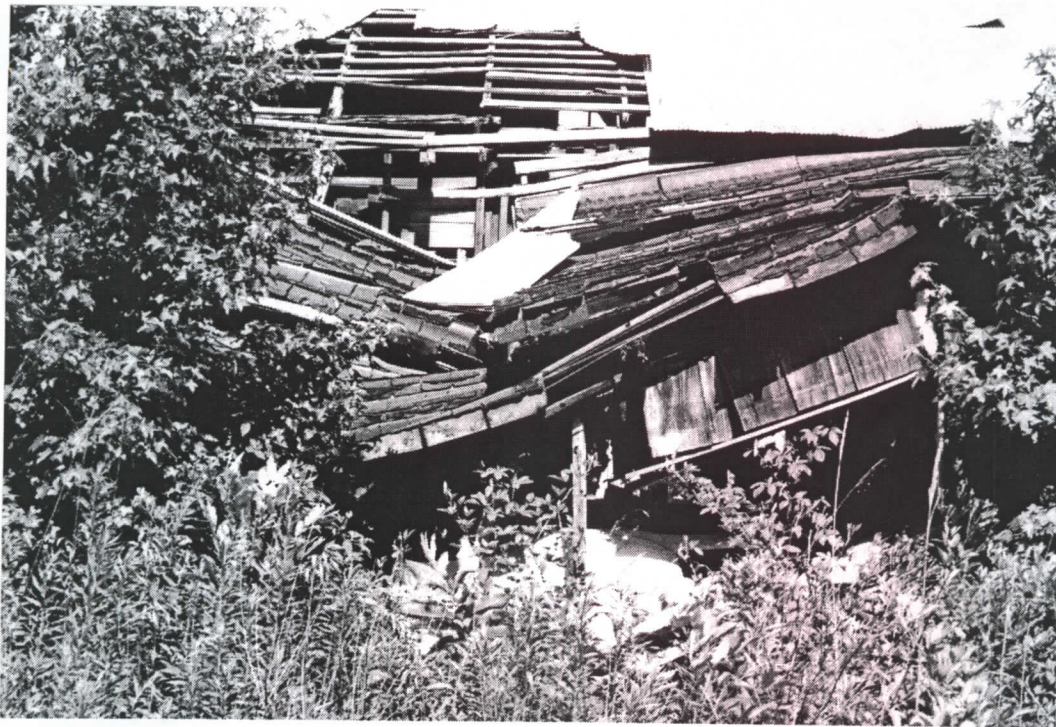
Photograph 15. Shed ell, west elevation. Note that the ell's roof is covered with asphalt shingles and not corrugated metal sheets.

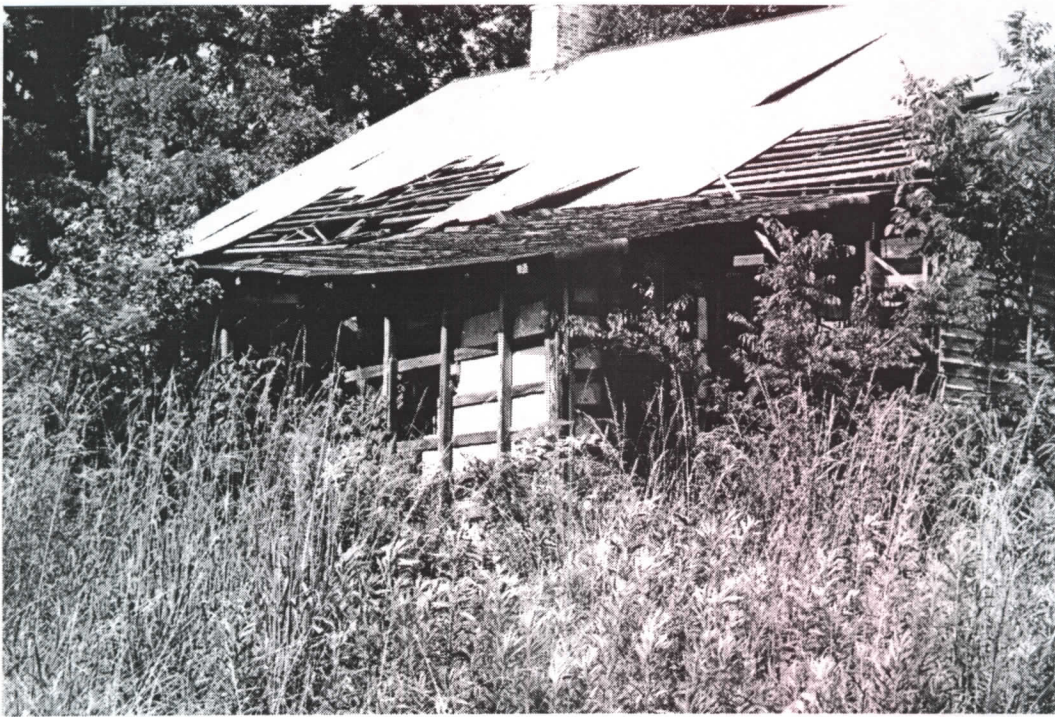
Photograph 16. Shed ell, southwest corner.

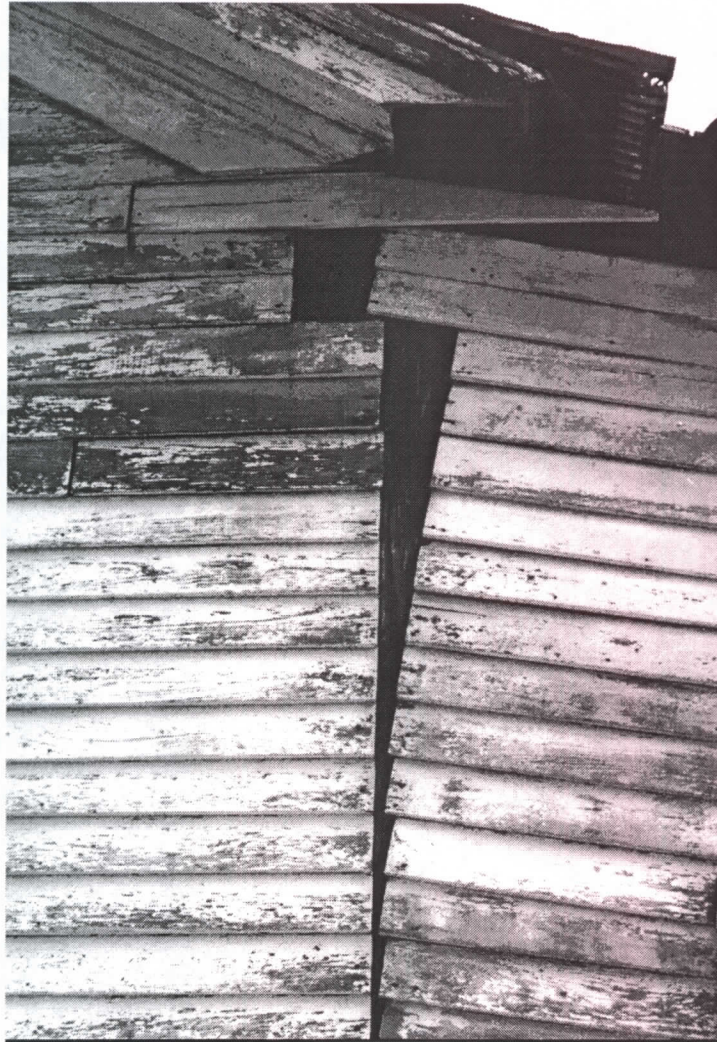
Photograph 17. Clapboards of the shed ell (north elevation) separating from the older portion of the house.

Exterior Fabric(s) Wood clapboards (attached with wire nails) [Photographs 8 & 17].
